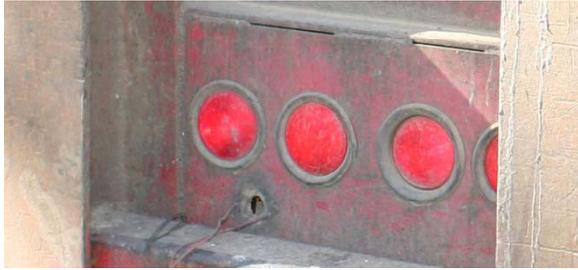
Most of you have probably noticed that many tractor-trailers and some heavy-duty trucks are fitted with modular tail light assemblies, like those shown in the photograph to the left. These units are held in place by heavy rubber gaskets which are placed in holes present in a rear metallic cross-member of the truck or semi-trailer.

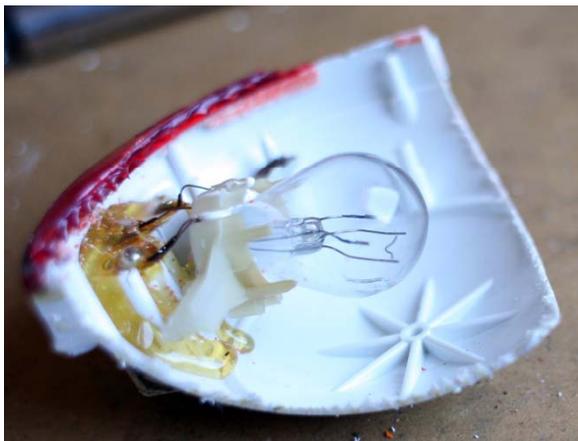
The photograph to the left shows the bulb in one such partially dissected assembly. This bulb contained one hot-shocked filament and one cold-broken filament. The physically larger filament is the one which glows brighter and is used for turn signals, brakes, and emergency flashers. The smaller filament glows for parking lights/running lights. Typically, the lower-intensity filament is incandescent during most periods of night-time driving, and some tractor-trailer drivers leave exterior lights on whenever they are driving.

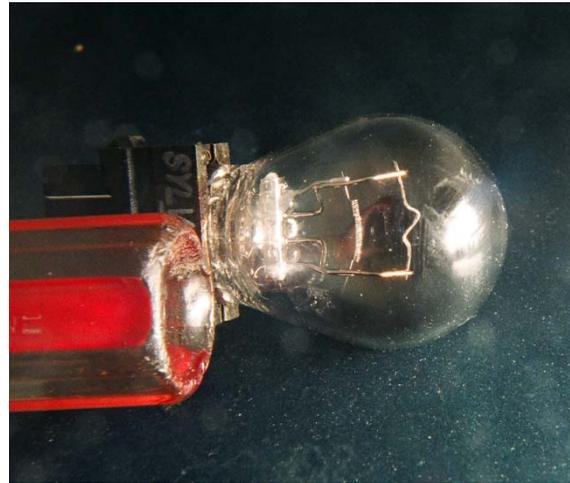
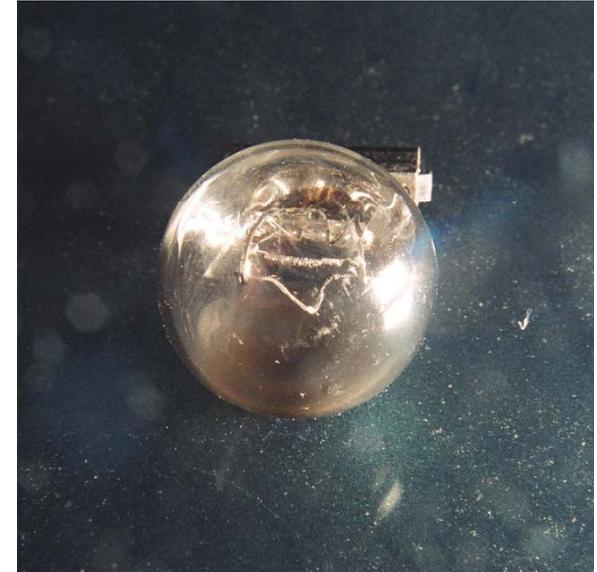
The two photographs above are different views of the same bulb. This is a more conventional automotive bulb. The typical two-filament automotive bulb has a circular base, usually of brass, or a rectangular plastic base with protruding electrical contacts. This bulb was removed from the rear of a pickup truck which had been struck in the rear. The abnormal appearance of the smaller filament shows that this truck's tail light was incandescent at impact. The normal condition of the larger filament shows that the brakes were not applied and that no turn signal or flasher had been used within the few seconds preceding impact. There will sometimes be a small amount of curvature in the filaments of a bulb. This curvature is usually an as-manufactured condition.

Filaments in lamps of this type are made of tungsten. Tungsten has some unique properties which make it ideal for lamp filaments and also provide means of determining if a bulb was on or off at impact. At ambient temperatures, tungsten is very brittle and chemically inert. If a cold filament is removed from a lamp and placed on the ground, it will stay clean and shiny for years. If a hot filament is exposed to air, it will oxidize rapidly and burn out almost instantly. Oxides of tungsten take many forms and colors, the most common being a white or yellow powder similar in appearance to talc and a dark, blackish-blue surface on the filament, similar in appearance to a blued gun barrel. In an incandescent state, tungsten is quite ductile; i.e., it deforms easily. When an incandescent filament in an automotive bulb is subjected to a high level of acceleration (typically above 20 times the acceleration of gravity), that incandescent filament will probably deform. After the accident, the deformation is permanent and can be observed, as in the bulb shown above. A filament which is not incandescent will not exhibit
