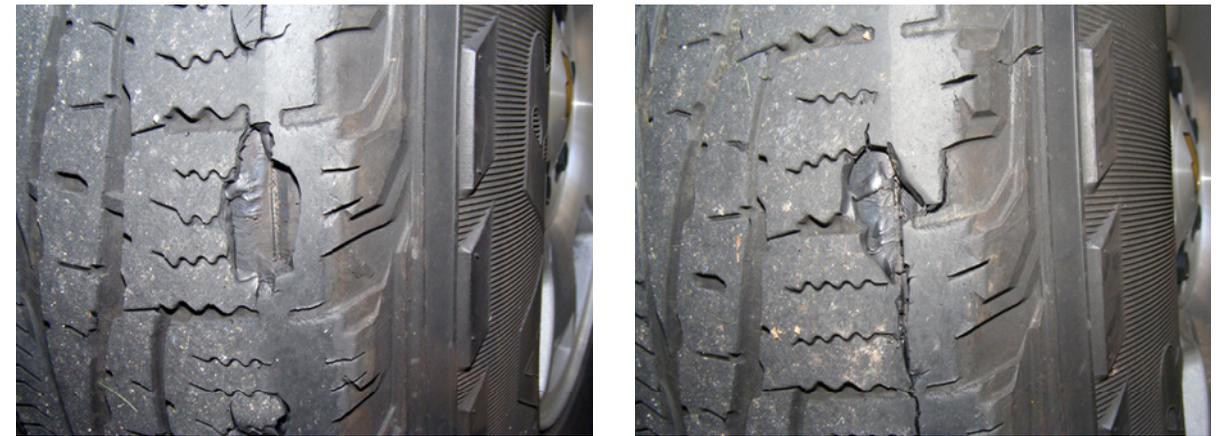
The two images above show different locations of a tire that was in service on my pickup truck and was in the process of self-disassembly. The current feature which was placed on my Web site on March 22, 2009, shows more photographs of that tire and gives more details. As I write this newsletter, I believe that the March 2009 current feature will still be on my Web site at www.ralphcunningham.net when you receive this edition. The proverbial bottom line on this impending failure is that the tire was in the process of developing a tread belt separation which began at the outboard edge because a penetrating object remained in this tire for an indeterminate amount of time before it was removed and the puncture was repaired. That extended period of operation with a penetrating screw allowed contaminants into the region of the two steel tread belts and was causing their separation, which was becoming manifest at the tread shoulder. User abuse (whether intended or accidental or inadvertent) is the cause of most of the tire failures I have been asked to investigate over the last 37 years. Tread separations are a less obvious manifestation of abuse or neglect. Overall overheating and subsequent failure from ply separations or cord failure are obvious indications of severe overdeflection, which is almost universally the result of underinflation in a tire from a private passenger vehicle. Impact-induced failures generally create diagonal splits in bias-ply tires (there are still a few of those in service) and radially oriented splits in radial-ply tires. In a few cases in which I have been involved, loss of control for some reason other than tire failure has caused a tire to be debanded; after the car has come to rest, the discovery of the deflated and debanded tire suggests that tire failure may have caused the loss of control. There has been more than one case in which a “failed” tire sent to me for failure evaluation has been placed on an undamaged rim of the proper size and shape and was found to hold air normally. Not that you would ever want to put that tire back into service, but it obviously did not fail until some lateral force pulled one of its beads away from the rim flange. Commercial vehicle tire failures are very similar to those in tires sized for private passenger vehicles, small utility trailers, boat trailers, and other, smaller, highway vehicles, but I avoid evaluating failures in commercial tires because of the difficulties associated with handling and storing them.
