Ralph's Accident Reconstruction Newsletter: Volume 10, Number 4—Autumn 2011

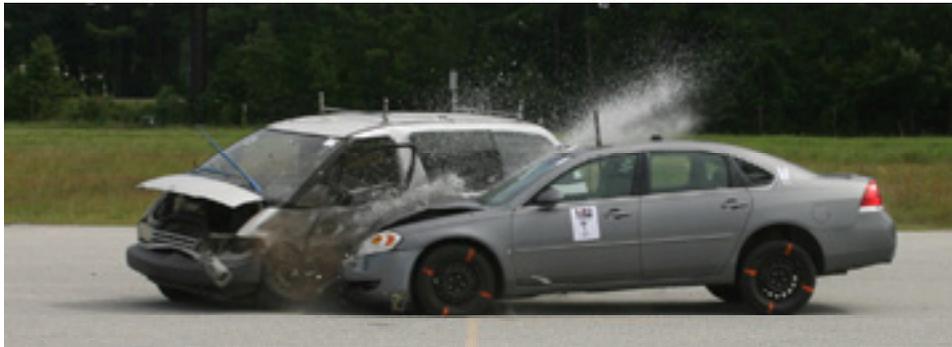
There was a joint crash conference of the South Carolina Association of Reconstruction Specialists (SCARS), the Southeast Accident Reconstruction Society (SeARS), and the International Association of Accident Reconstruction Specialists (IAARS) in Mt. Pleasant (Charleston), South Carolina, for the last full week of July. Monday, July 25th, was devoted to staged collisions and other outside work. Tuesday through Friday involved training sessions, with presentations given by a variety of people involved in reconstruction. I was a presenter for one morning session. I had given a presentation at last year's SCARS conference, and they apparently liked what I had to share with them, since I was invited to return as a speaker this year. There are photographs of some of the field activities at that conference in this newsletter.

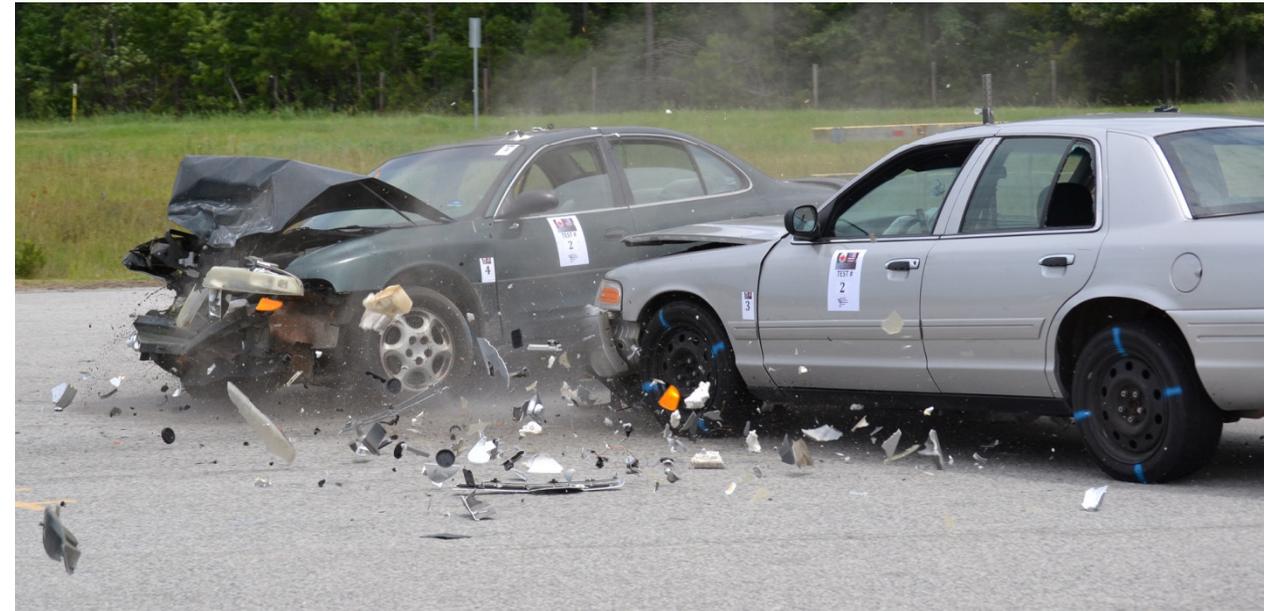
The photo in the column to the left shows an Impala-Previa collision shortly after first contact. The Previa was equipped with a six-degrees-of-freedom accelerometer, the first staged collision I've witnessed where such a device was available. It showed that the Previa rotated over 90 degrees in the first one second after impact, a very substantial initial angular velocity. Had there been any unrestrained occupants inside the Previa on the left side, it is very likely that they would have been ejected through windows on the left side of the minivan.
