Ralph's Accident Reconstruction Newsletter: Volume 11, Number 6—Late Autumn 2012

Ralph's Accident Reconstruction Newsletter

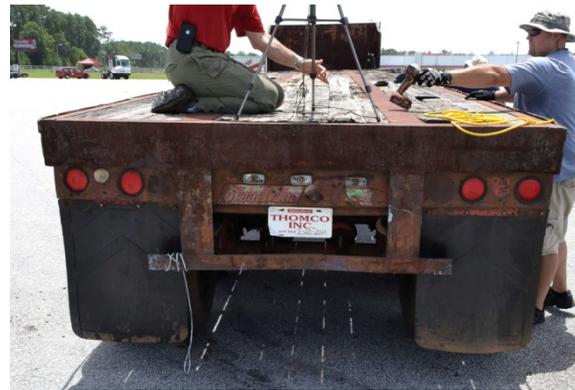
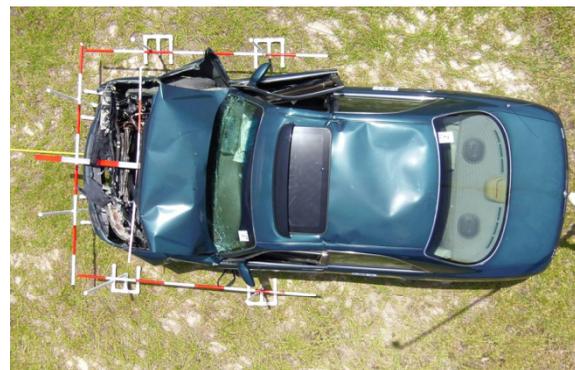
The two photographs at the top left of the right column of this newsletter show the rear of the trailer after the impacts and an overhead view of the car which struck it at 35 mph. The underride guard at the rear of this Great Dane trailer was much more structurally sound than Federal standards require; it did not fold under or break, and it exhibited very little permanent deformation.

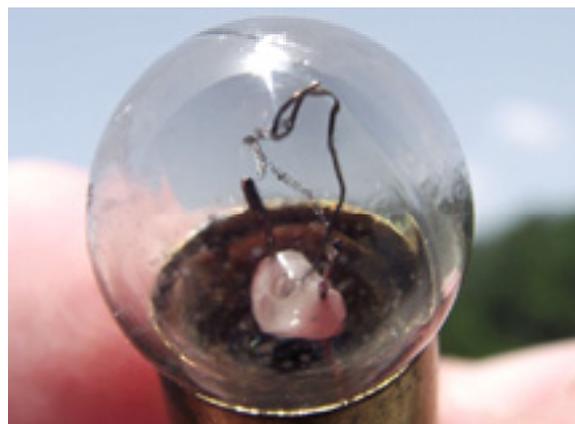
One of the purposes of these two collisions was to determine if the rear impact by a car at 35 mph could cause sufficient acceleration of the trailer to create hot shock in the filaments of the marker (“clearance”) lights. These lights were powered by a 12-volt battery during both crashes, and the bulbs were examined after the crashes. The closeup photograph of the bulb (below the overhead view of the car) shows severe hot shock in the filament of one of the incandescent bulbs from the rear of the semi-trailer.

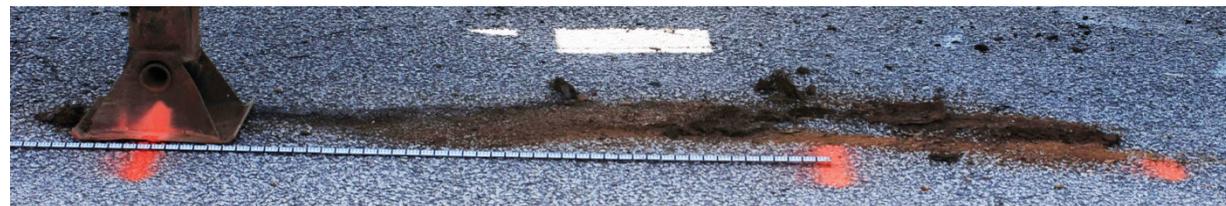
As mentioned, the trailer was displaced by the impacts. The photo at the bottom of this text shows the movements from the two collisions. This photo was taken under the trailer, in shade, so it is quite dark. (I didn't take it.) At the far left in the photograph is the foot of the trailer's landing gear. Its position before the first impact was marked by a red line on the pavement—that is the small red paint mark evident near the right side of the photo. The red line to its left is the location of the landing gear foot after the first impact. The distance between the middle red line and the one nearest the left side of the photograph is the amount the semi-trailer moved in the second impact. Because the second collision involved a heavier car traveling at a higher speed, there was greater displacement of the trailer as a result of that impact. Had this trailer been connected to a truck tractor, the distance from the second collision would probably have been only half as great. Load on the trailer would have further diminished the post-impact travel which resulted from the rear impacts.
