**Ralph Cunningham
Accident Reconstructionist**

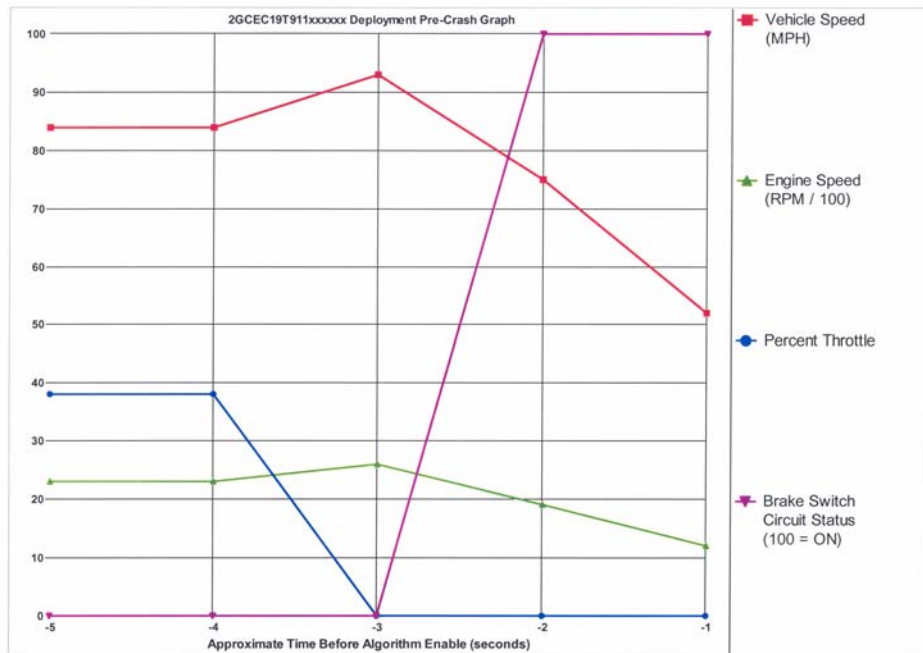
The chart above presents four different vehicle parameters taken at one-second intervals in a five-second time span proximate to the crash. What the chart shows as “Vehicle Speed” is actually taken from the speed sensor on the output end of the transmission; a traction wheel that is slipping on the pavement or spinning in air can cause the tabulated vehicle speed to be substantially different than its actual linear speed over (or above) the ground. But often the conditions shown in this chart and in the graph of delta v can be linked to physical evidence through a reconstruction. This collection of data can be a powerful augmentation to a good reconstruction, and the data stored in the SDM may reveal conditions or evidence which would not otherwise be observable or obtainable after a crash without such an electronic device. Please call me if you need this service or wish to discuss any of the services I offer.
