Ralph's Crash Reconstruction Newsletter: Volume 12, Number 8—Late Autumn 2013

The crash conference held in Charleston in July featured two rear underride crashes in which Ford Crown Victoria sedans were towed into the rear of a semi-trailer. One of those crashes occurred at a relatively low speed, while the other was at higher speed.

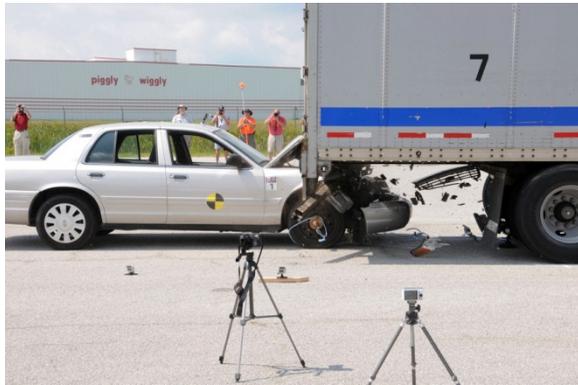
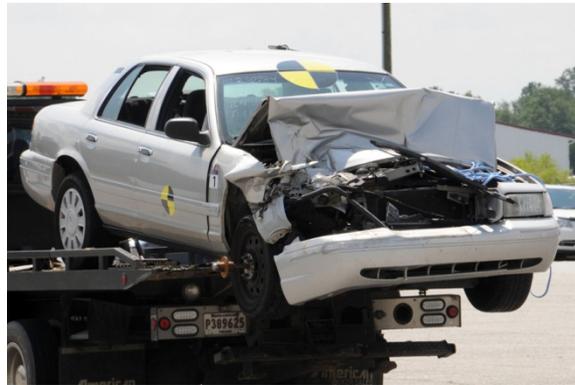
The first rear trailer underride involved a 2007 Crown Victoria striking the rear of a 2001 Wabash 53-foot van trailer. The impact speed was 19 mph. The photograph to the left below was taken during the crash; the photograph on the right shows the damage at the front of the Ford.

For many years, Ford vehicles which stored crash data used the Powertrain Control Module (PCM). The PCM was supposed to freeze a complex set of data upon receiving a Restraint Deployment Signal (RDS) from the Restraint Control Module (RCM), which was the unit which fired airbags (and pre-tensioners, if the vehicle had them) whenever there was a deployment. Often, however, no RDS was received by the PCM after a deployment, which meant that the PCM would continue to record data, overwriting the crash event typically in about 20 seconds, unless someone turned off the vehicle's ignition switch. For the two Ford underride crashes, a man was standing nearby, ready to run and turn off the ignition to preserve crash data in the PCM. For this first crash, the impact speed was 19 mph. There was no deployment of pre-tensioners or airbags, so no RDS was sent. The semi-trailer, which was coupled to a truck tractor at the time of this impact, was moved forward a few inches when the Ford struck it in the rear, indicating a delta-v for the tractor-trailer combination of two mph.

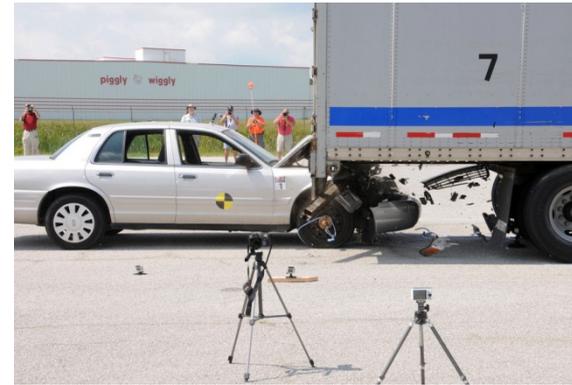
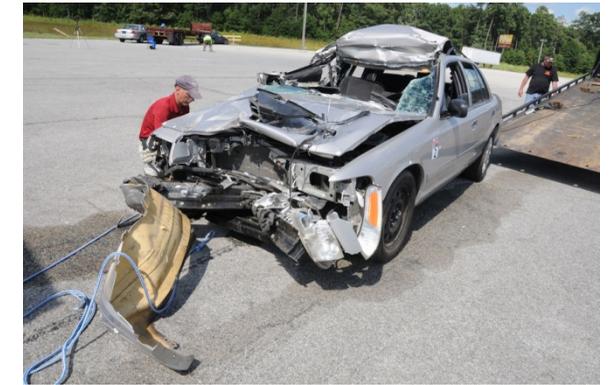
The second collision occurred at twice the speed of the first: 38 mph. The photograph on the left side at the top of the column of text to the right was taken during the collision, before motion stopped; the photograph to the right of it shows the damages to the Ford. As you can see by comparing damages, penetration in the first collision did not reach the windshield, whereas the penetration experienced during the second collision includes the right A pillar, the windshield, and the roof. The airbag in this vehicle deployed, but not until the Ford reached the left rear tires of the trailer. The RDS which was supposed to have been sent by the RCM after the deployment was not received by the PCM, but the runner with a mission turned off the key in time to preserve

data in the PCM. The tractor-trailer was moved 21 inches by this second impact, indicating a delta-v for that truck of 4.5 mph. Interestingly, the speedometer of the second Ford involved in the rear underride testing was found stuck at 52 mph after the crash, although its impact speed of 38 mph was well-documented and verified. Sometimes a stuck speedometer or tachometer needle means something, sometimes it doesn't.

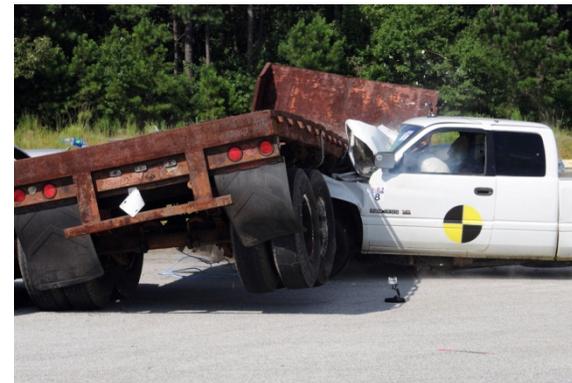
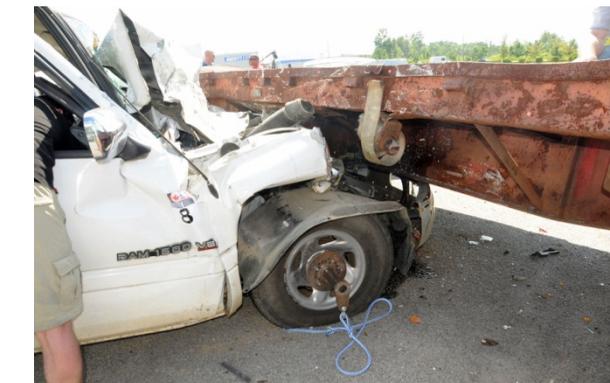
There was a third staged underride crash on Monday. This involved a Dodge Ram pickup truck which struck the side of a flatbed semi-trailer. Those of you who have been reading my newsletters for a while probably recognize the trailer as the same one which was used in some crash testing at the 2012 seminar. The photograph on the left, below, shows the Ram at maximum engagement with the semi-trailer. The photograph on the right shows the other side of the Ram at rest after the impact. The 37-mph impact by the 4500-pound pickup truck may have rendered this semi-trailer unfit for future crash tests at subsequent seminars.
