Ralph's Accident Reconstruction Newsletter—Volume 5, Number 1—January 2006

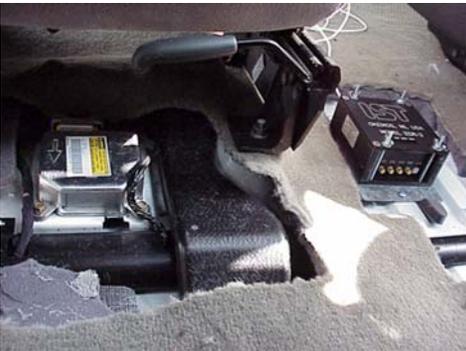
The photograph to the left shows the SDM which was standard in the Camaro (to the left) and the IST three-axis accelerometer, which is a very accurate device. The IST accelerometer was securely mounted to the floor of the Camaro, near the SDM. The primary purpose of the accelerometer in the SDM is to monitor large changes in speed to evaluate whether or not the airbags should be deployed, and it monitors (and may record) acceleration in only one plane—the car's longitudinal, or front-to-rear, axis.

Even though the accelerometer in the SDM (Sensing Diagnostic Module) only monitors acceleration in one plane, and it is not a laboratory-grade piece of equipment, numerous tests where an SDM has been present in a car which was instrumented with IST or other very precise accelerometers have shown that it is surprisingly accurate in the longitudinal plane. The SDM is General Motors' name for the Event Data Recorder (EDR) placed in virtually all of its late-model cars and light trucks.

The trap showed that the Camaro was traveling 36.5 mph at impact. The Camaro's delta-v was 15.9 mph in 130 milliseconds of collision with the Corolla. The Corolla's delta-v was 21.6 mph. The SDM in the Camaro reported an impact speed of 35 mph. The SDM also reported a delta-v of 14.5 mph. Numerical evaluation of the post-crash data using momentum principles and reasonable ranges for values not specifically known yielded an impact speed in the range of 34.7 to 37.3 mph.

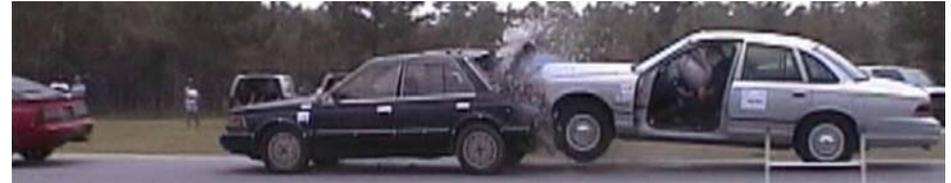
The picture above shows the third staged collision sequence. A 1994 Ford Crown Victoria was driven to collide with the rear of a parked 1985 Nissan Maxima, which was propelled by that collision into the rear of a parked 1989 Chrysler Conquest. The delta-v to the Crown Vic was 19.9 mph. The Maxima departed from this collision with an initial speed of 20.7 mph. (It was lighter than the Crown Victoria.) It moved forward from that rear impact to collide with the rear of the parked Conquest. A primary purpose of staging this sequence was to demonstrate that conservation of momentum principles can be applied to both collisions. One of the interesting aspects of attending conferences like this is to watch these staged collisions. All were surprised at the degree to which the front of the Crown Vic rose at impact, only to bounce down hard when the Maxima moved away from it. The speed of the Crown Vic at the instant of impact was 37.8 mph.
