## Ralph's Crash Reconstruction Newsletter: Volume 13, Number 6—Autumn 2014

**Ralph Cunningham, Inc.**  
**Accident Reconstruction**  
**[www.RalphCunningham.net](http://www.RalphCunningham.net)**

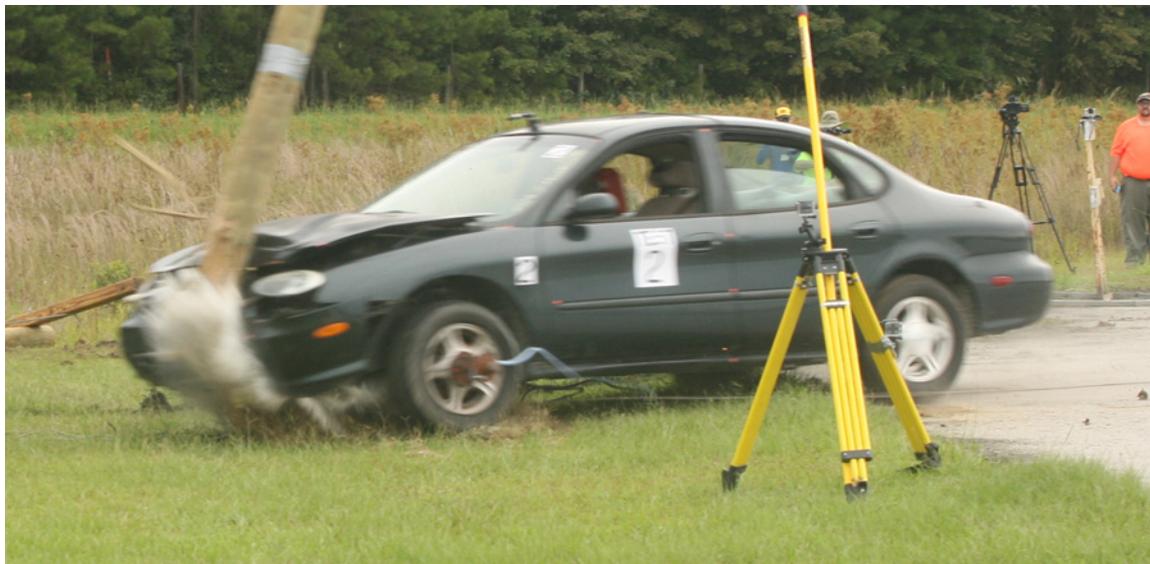
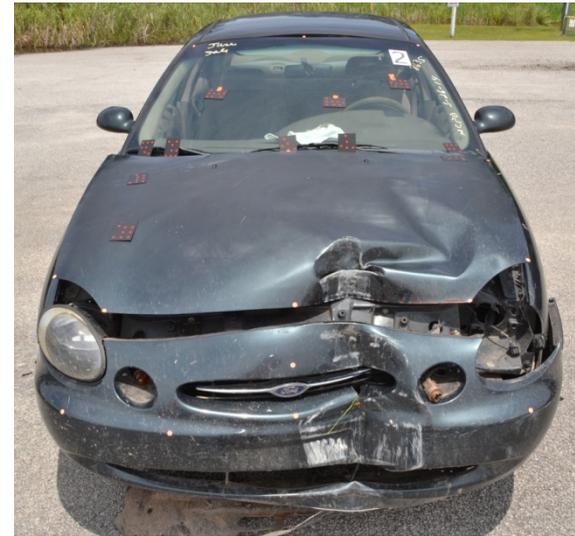
There were two car-to-pole staged crashes at the 2014 crash conference in Charleston, SC. The photograph below shows the Ford Taurus milliseconds after it first made contact with the pole. The photograph at the top of the next column shows the front of the Taurus after that staged collision. The struck pole was of 6-30 type. It was broken at a point 2 feet above ground level as it was installed. The stub remaining in the ground was partially extracted as the Taurus rode over it. The Taurus traveled 180 feet after impact. Numerical analysis of the energy involved in damaging the front of the Taurus, in breaking the pole, in partially extracting the pole, and the remaining energy after leaving the pole (as demonstrated by its post-impact travel) revealed a calculated impact speed of 51 mph. The documented (instrumented) impact speed was 50 mph. Close enough!

One interesting aspect of the damage to the Taurus was the difference between the apparent crush and the actual crush. After impact, the permanent, inward deformation of the front bumper appeared to be seven inches. Was that the amount of crush needed to be used to determine an equivalent barrier speed for the damage? No! The front fascia had a foam backing which was originally four inches thick in the region of the crush. The structural steel crossbar behind the front fascia, which actually served as the structural member which provided most of the impact strength,

was actually crushed to a distance 19 inches to the rear from the original front of the Taurus, meaning that the actual rearward crush of the structural component was 15 inches—19 inches minus the four-inch thickness of the foam, which provided no significant crush resistance. The front fascia and foam had significant restitution, rebounding substantially forward after impact. This characteristic is common with many modern vehicles—when measuring the crush, it is important to notice whether or not the fascia has any foam backing and what the depth of that backing is and to measure any deformations which occurred in any structural components. Also, with pole and tree impacts, it’s important to measure the diameter of the struck object.

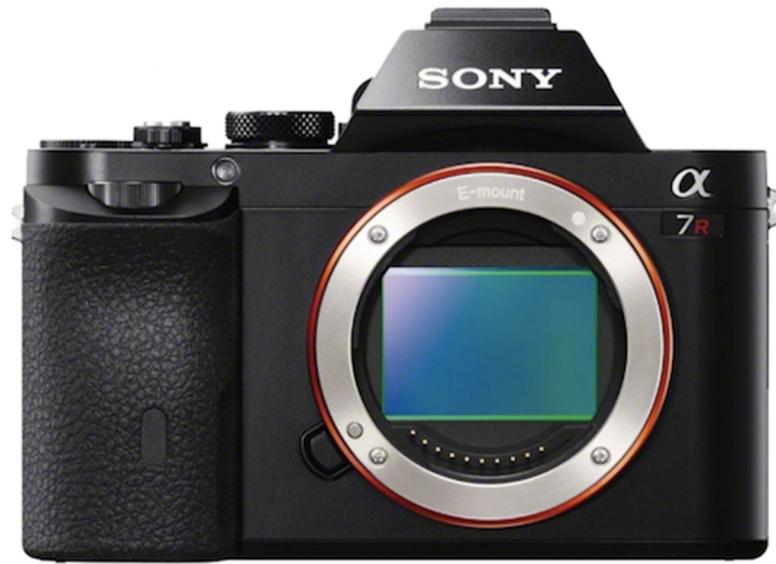
More new hardware! To be able to take better photographs under a wider variety of conditions, I have added three new cameras to my collection. The camera shown to the left of this text is my best mirrorless camera, a Sony Alpha a7R, which features a 36.8 megapixel, full-frame (essentially 24 x 36 mm) image sensor. Since it is mirrorless, it has a 2.4-million dot OLED electronic viewfinder. It includes automatic ISO sensitivity or an ISO range of 100 to 25600 and has a burst rate of four frames per second with full 36

MP size images, among many other features and capabilities. This camera provides images with the sharpness and quality of a medium format camera without the size, weight, and huge cost of medium format. This camera and the two described below both use Class 10 SDHC cards.
