Those of you who read my December 21, 2004, Web-site current feature may recognize these photographs. These are two views of the tire and rim from one side of the rear axle of a late-model pickup truck which was involved in a collision in 2004. Because this is an active case, I am not at liberty to divulge many details. What happened in this case is that the driver of the pickup truck on which this tire and rim were mounted lost control in heavy rain and entered the opposing lane of travel on a two-way highway; the collision was fatal to the driver and sole occupant of the pickup.

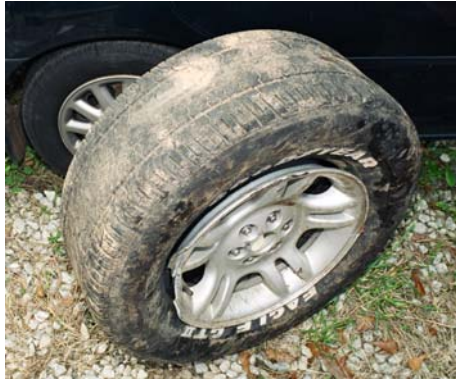
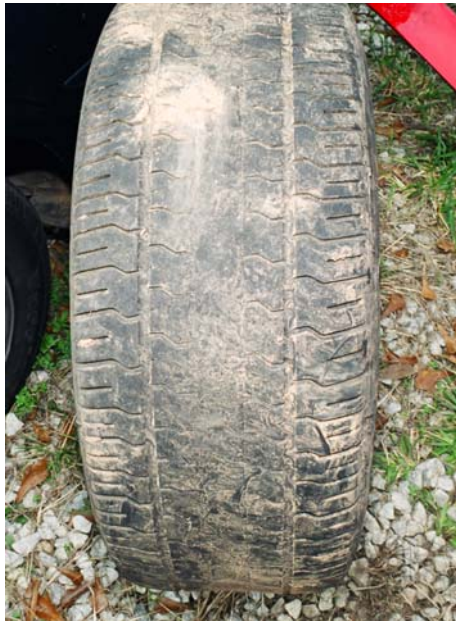
This was a late-model, half-ton pickup truck in generally excellent mechanical condition. All four tires on this vehicle were the same brand/type/size. These tires were several sizes wider than the factory option tires, but the service history of this truck is unknown to me. The four tires on this truck were essentially identical, except that the two tires on the front axle had adequate and relatively uniform depth of tread, while the two tires on the rear axle had greatly accelerated wear of the inner ribs of the tread, leaving depths of 2/32 to 3/32 inch for the inner two grooves of one of the rear tires and depths of 2/32 inch or less for the inner two grooves of the tire shown in this photograph. This wear pattern indicates that these tires were operated in an overinflated condition for a prolonged period of vehicle service. It also appeared likely that this truck's tires had not been rotated with any regularity.

For any given tire, the proper inflation pressure depends primarily upon the load it is carrying. A pickup truck is designed to carry stuff (cargo, tools, whatever), but many persons use a pickup truck as a primary means of transportation without cargo. When the truck is not carrying any cargo, the rear tires have a substantially lower load than the front tires; for many pickup trucks, using the same inflation pressure in the rear tires as in the front tires will result in overinflation of the rear tires. If those tires aren't rotated, they will look like the tire shown in these photographs in approximately the same mileage that it takes the front tires to wear half of the useable tread. On a dry road, there is very little difference in the traction capabilities of a tire with normal tread and one which is essentially worn out ("bald"), but, on a rain-wetted road, the traction capabilities of a worn tire are greatly compromised. When a tire travels on a wet road, the leading edge forms a wedge of water. The grooves of the tread provide an escape path for this water, allowing the rear of the contact patch to make intimate contact with the pavement; traction is slightly reduced from that which is available on a dry road, but that reduction is generally not substantial. When a bald tire is driven on a wet road, however, there is no escape path for the wedge of water, and the tire "floats" atop the wedge, resulting in a major reduction in traction capabilities. On a pickup truck, the rear tires are also providing the driving torque. When a bald, driven tire hits water on the pavement, loss of traction is virtually guaranteed. That loss of traction does not always result in loss of control, but, when it does, there can be very serious consequences.

Since the driver of this truck was killed, we will never know whether or not he was aware of the condition of his rear tires. But I have often heard people make comments about tires indicating their belief or understanding that the "good" tires should always be on the steering axle. For virtually all
